DEPARTMENT OF TRANSPORTATION

Contract #: 04-0120F4Cty: SF/ALA Rte: 80 PM: 13.2/13.9File #: 69.28**WELDING INSPECTION REPORT****Resident Engineer:** Pursell, Gary**Address:** 333 Burma Road**City:** Oakland, CA 94607**Report No:** WIR-014282**Date Inspected:** 12-May-2010**Project Name:** SAS Superstructure**OSM Arrival Time:** 700**Prime Contractor:** American Bridge/Fluor Enterprises, a JV**OSM Departure Time:** 1900**Contractor:** Zhenhua Port Machinery Company, Ltd (ZPMC), Changxing Island **Location:** Shanghai, China**CWI Name:** Wu Zhi Chang**CWI Present:** Yes No**Inspected CWI report:** Yes No N/A**Rod Oven in Use:** Yes No N/A**Electrode to specification:** Yes No N/A**Weld Procedures Followed:** Yes No N/A**Qualified Welders:** Yes No N/A**Verified Joint Fit-up:** Yes No N/A**Approved Drawings:** Yes No N/A**Approved WPS:** Yes No N/A**Delayed / Cancelled:** Yes No N/A**Bridge No:** 34-0006**Component:** Orthotropic Box Girder (OBG)**Summary of Items Observed:**

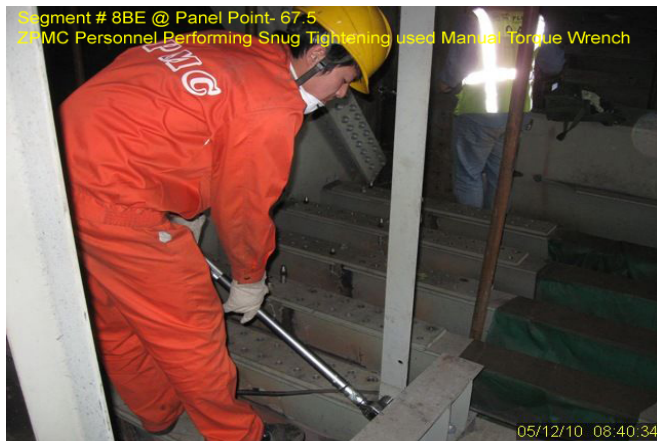
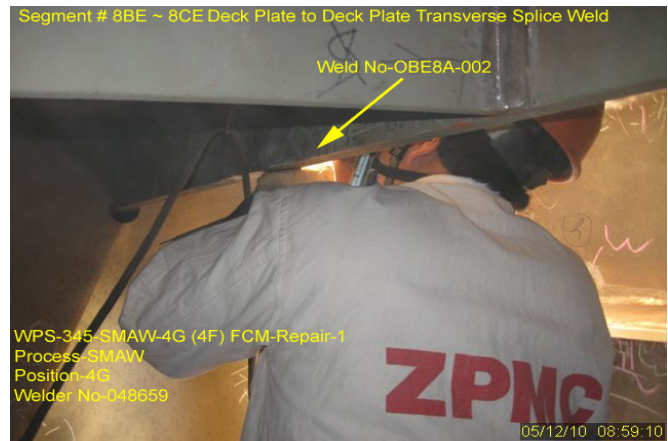
This Quality Assurance (QA) Inspector witnessed final tension verification for Cable Tray at Panel Point (PP) 61 ~ PP 71 for Segment 8AE ~ 8CE. Inspected 10% on a random basis and found the tension to be in general compliance. Inspection was performed against the Notification No. 00346 Dated May 12, 2010

Bolt sizes used were M19 x 55 RC Set# DHG60580 and final torque required was 340 N-m.

Manual Torque wrench was been used with Sr. No. 0900001 Please refer the pictures for more comprehensive detail.
